# UNDERWATER BRIDGE INSPECTION REPORT

STRUCTURE NO. 36518

CR NO. 82

W. FORK OF THE BLACK RIVER

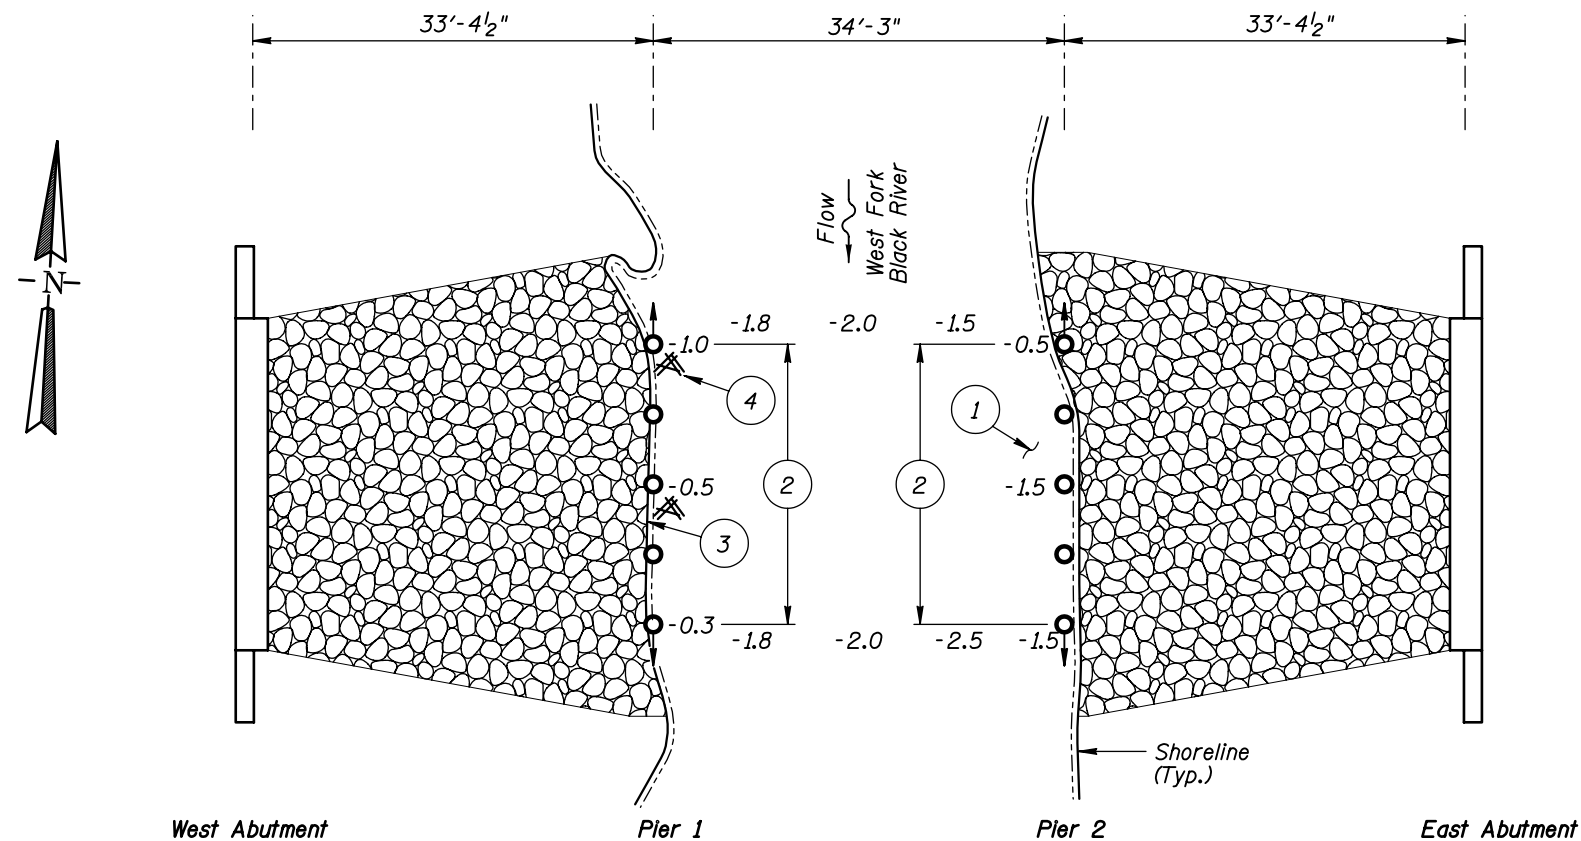
**INSPECTION AND SOUNDING PLAN**

- The channel bottom consisted of 1- to 2-foot-diameter riprap and silt with approximately 6 inches of probe rod penetration.
- The steel pipe piles exhibited coating failure with up to 1/4-inch-diameter rust nodules and up to 1/32-inch-deep pitting over 10 to 25 percent of their surface area from the channel bottom to 5 feet above the waterline.
- Area of vertical embankment erosion 5 feet above the waterline.
- 6-inch-diameter and smaller timber debris scattered along the pier.

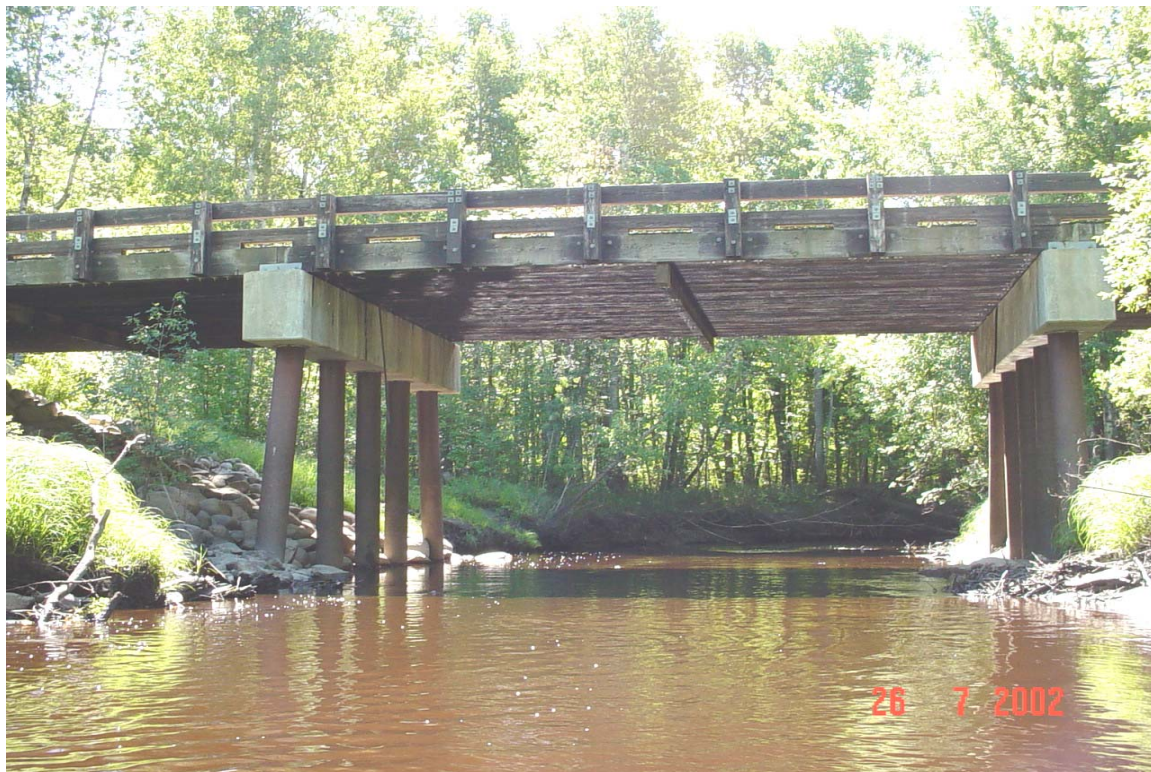
Photograph 1. Overall View of Structure, Looking South.

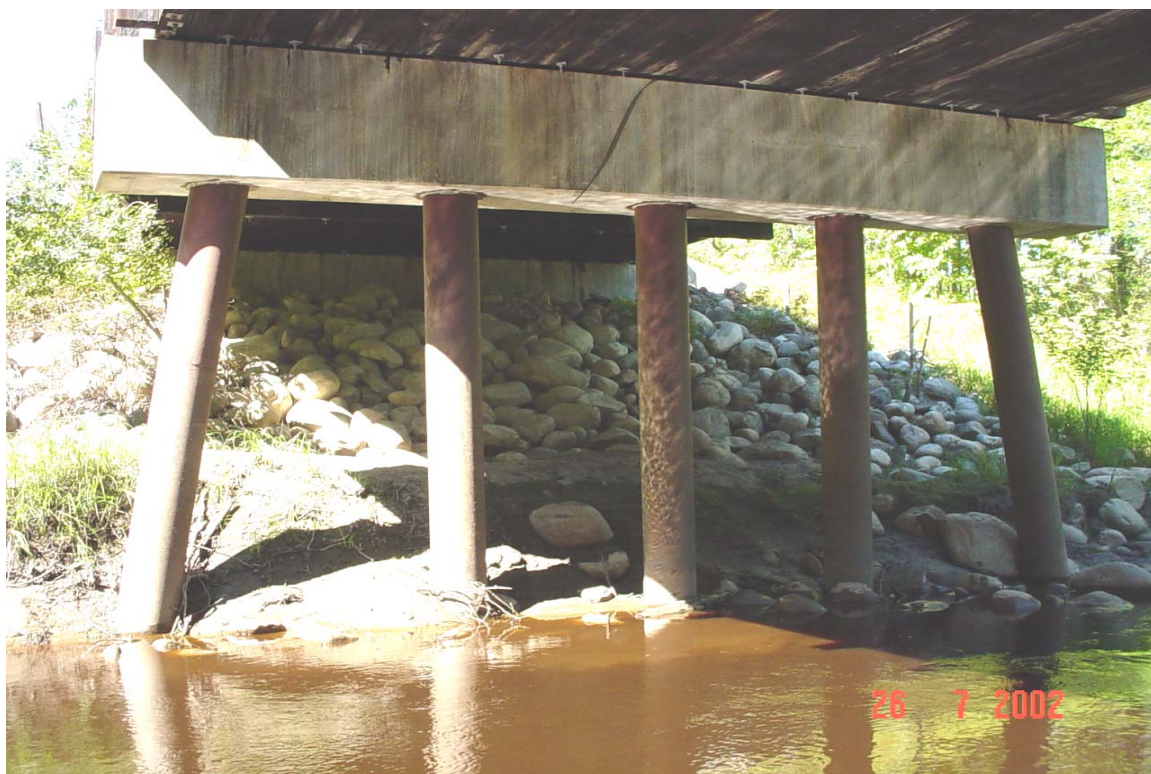
Photograph 2. View of Pier 1, Looking Northwest.

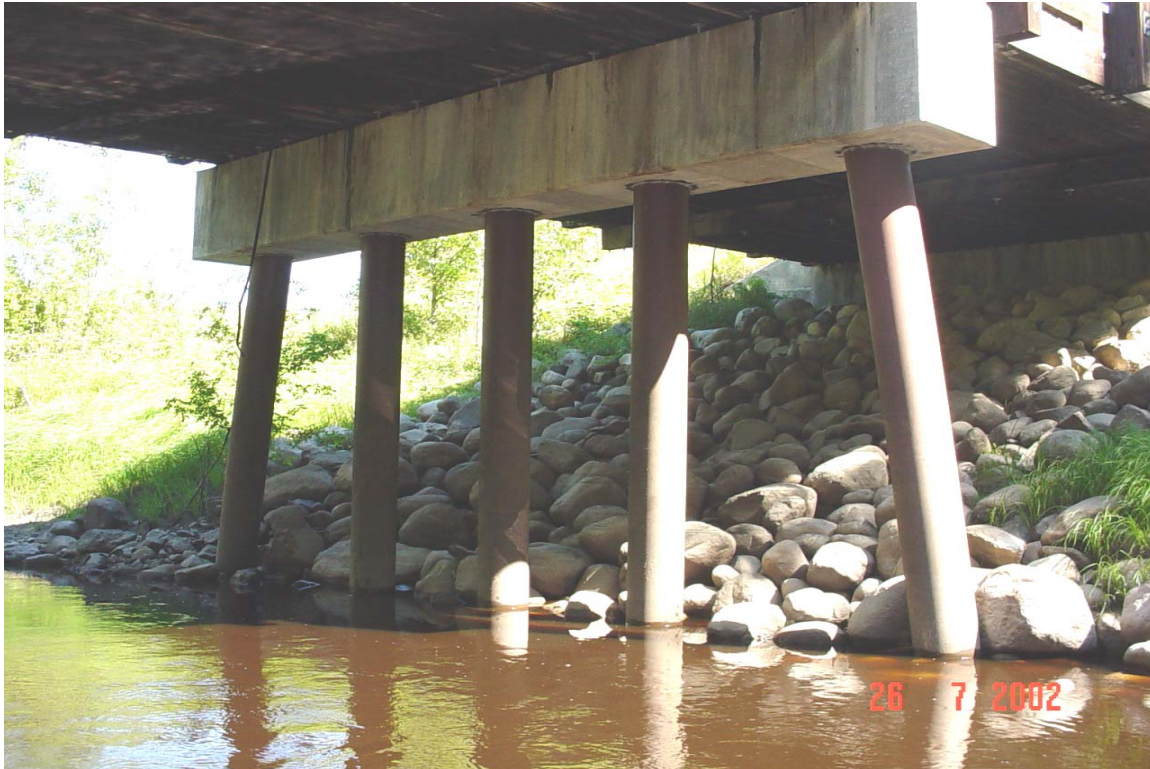
Photograph 3. View of Pier 2, Looking Northeast.

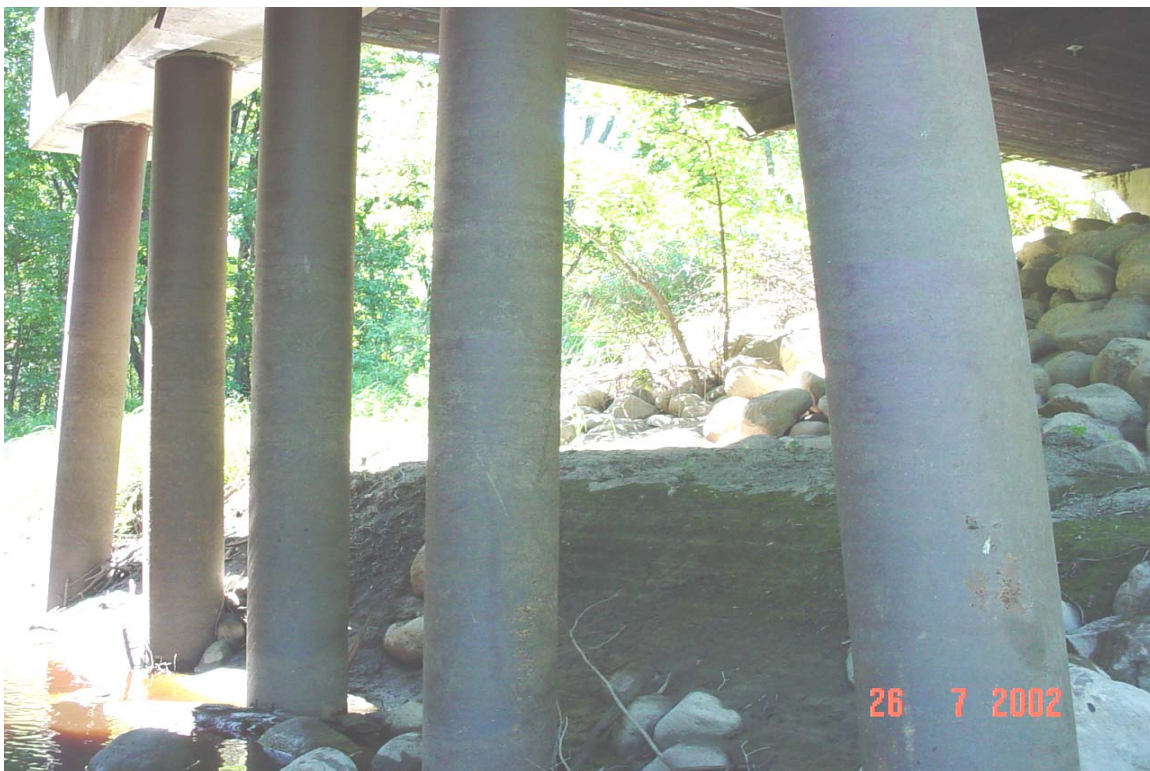
- (A) The steel pipe piles exhibited coating failure with up to 1/4-inch-diameter rust nodules and up to 1/32-inch-deep pitting over 10 to 25 percent of their surface area from the channel bottom to 5 feet above the waterline
- (B) An area of vertical bank erosion was observed at Pier 1. The embankment extended out to Pier 1 and exhibited 5 feet of vertical erosion above the waterline at the upstream and downstream noses of Pier 1.

Photograph 4. View of Typical Corrosion of Piles, Looking Southwest.
